Flood Effect Evaluation on:

SH-24 - North of Washington, Oklahoma
in
McClain County

Christopher R. Clarke &
Scott Cosby

Oklahoma Department of Transportation (ODOT) – Materials Division

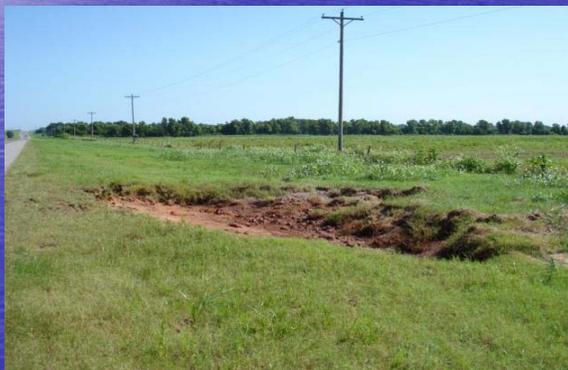
Geology of Test Site

- The geologic unit for the test site consists of red platy to blocky shales.
- Materials visually observed in a severe scour area caused by the first flood event off the NB shoulder of SH-24 at the test site seems to confirm the geology of the test area.

- The scour area was approximately 17 feet long, 10 feet wide, and 3 to 4 feet deep.

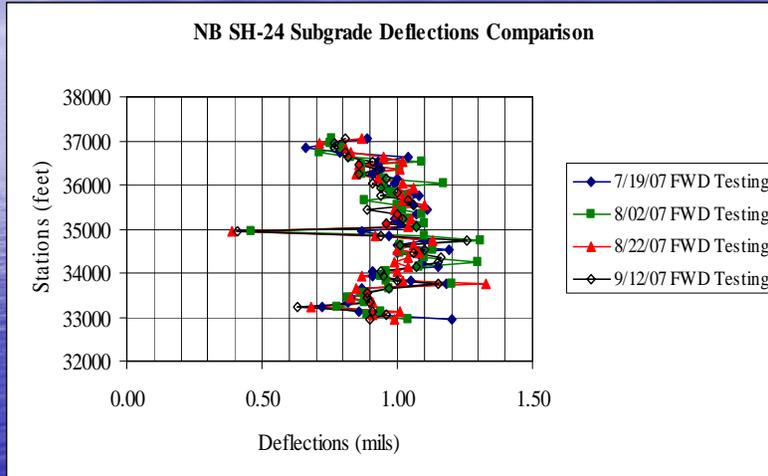
Deflection Comparison

- The 14 hr and 8 hr flood durations probably were not long enough periods to cause significant subgrade damage.
- From the deflection plots, there was slight weakness in the SH-24 test site. The subgrade strength did eventually return to the test site.
- The geology of the test site played a part as well. If the test site had more sandy than clay soils present then subsequent voids and severe weakness may have occurred in the subgrade.
